DOI FY 05 Aviation Mishaps

**5 Aircraft
Accidents**

**9 Incidents
with Potential**

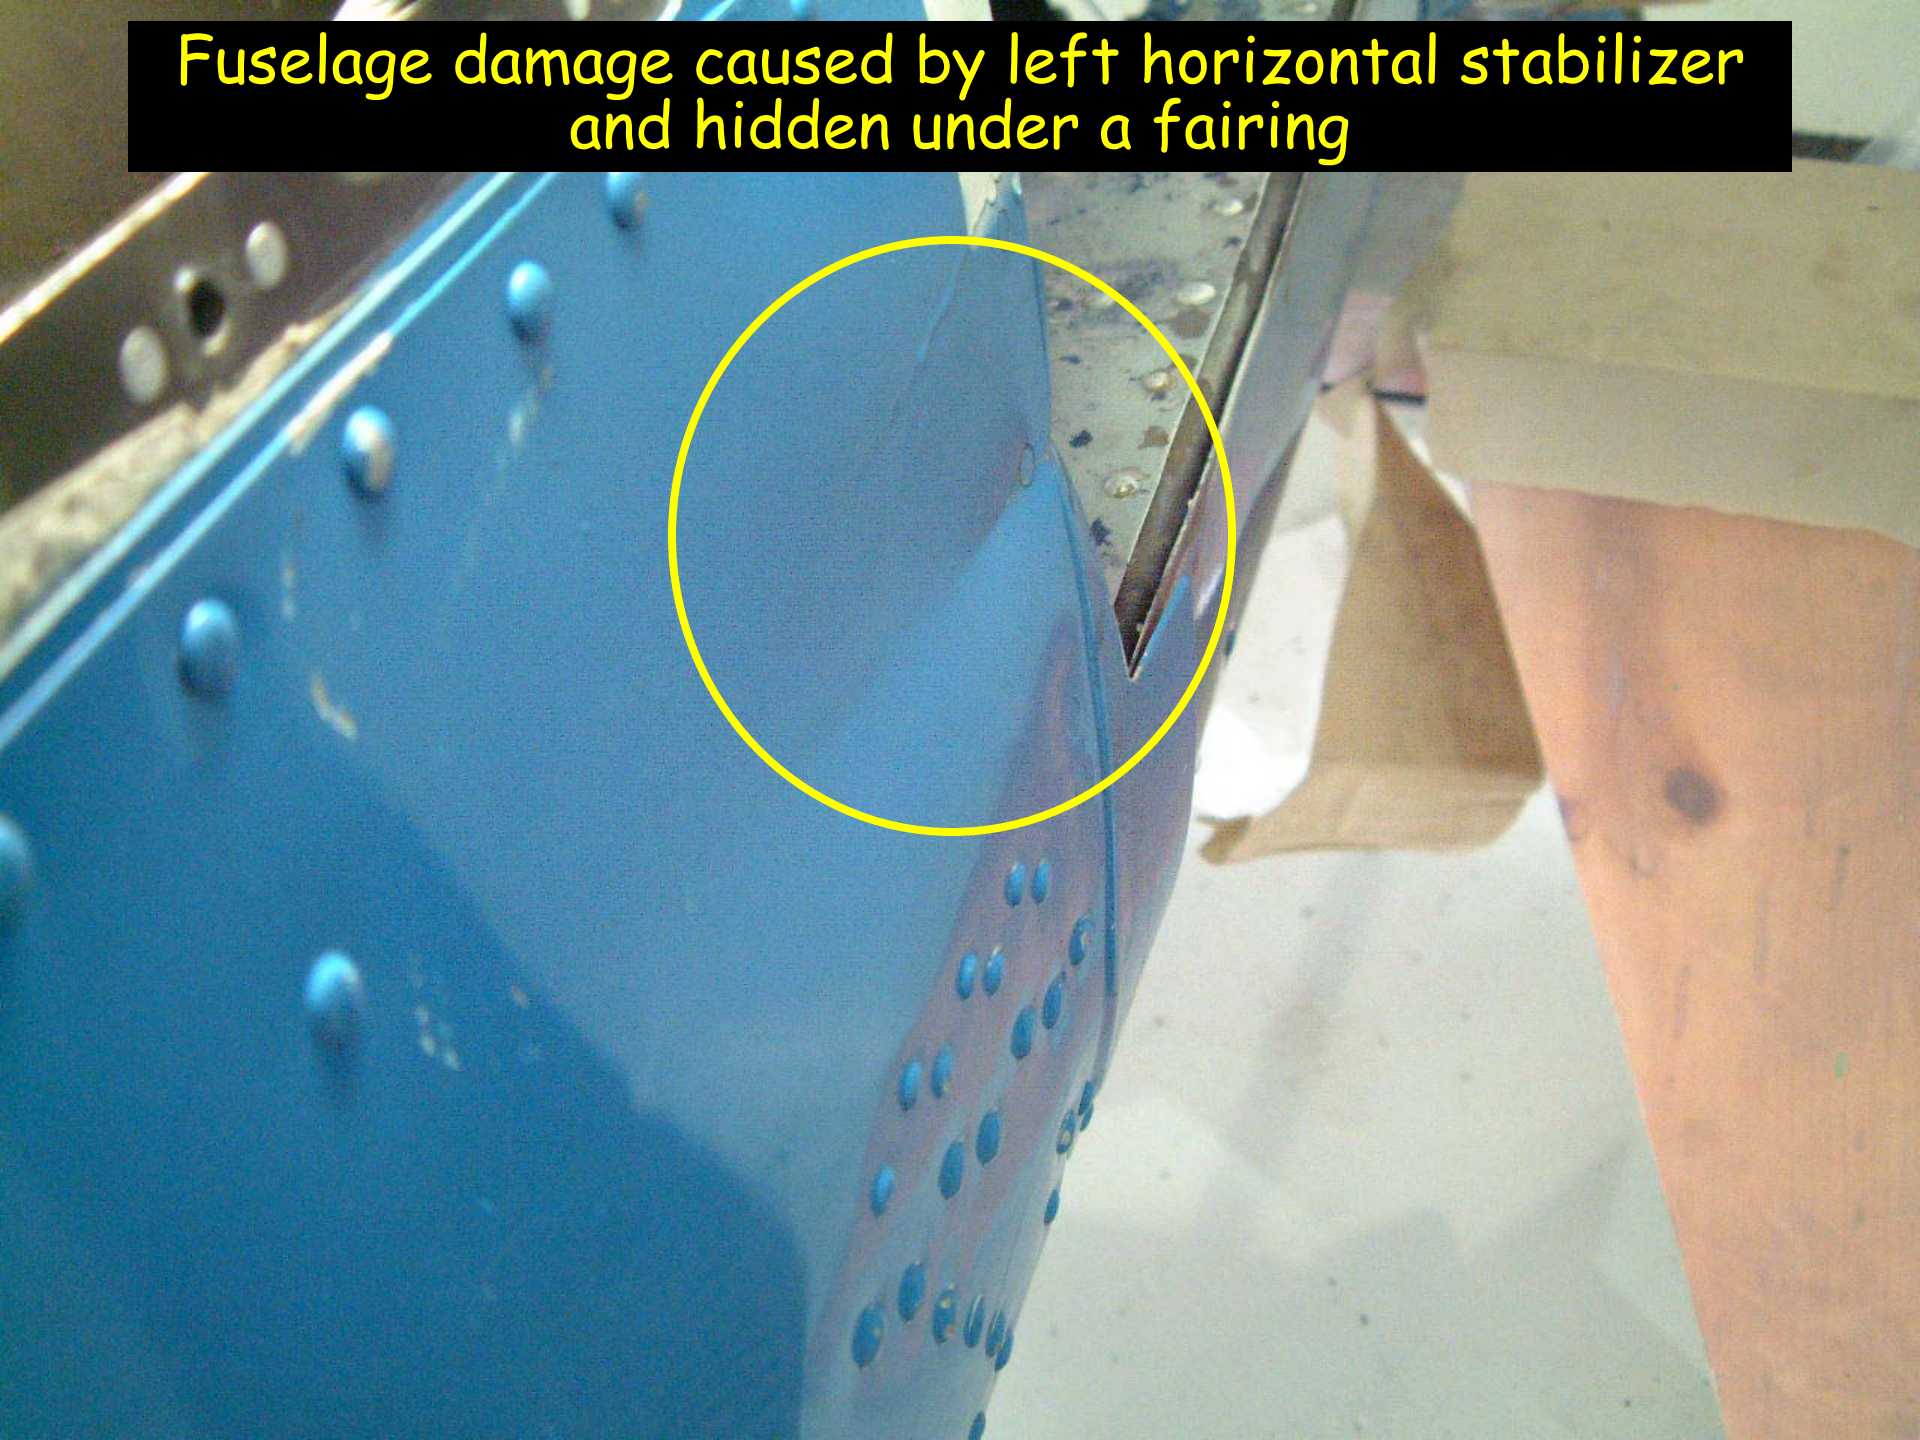
Fuselage damage caused by left horizontal stabilizer
and hidden under a fairing

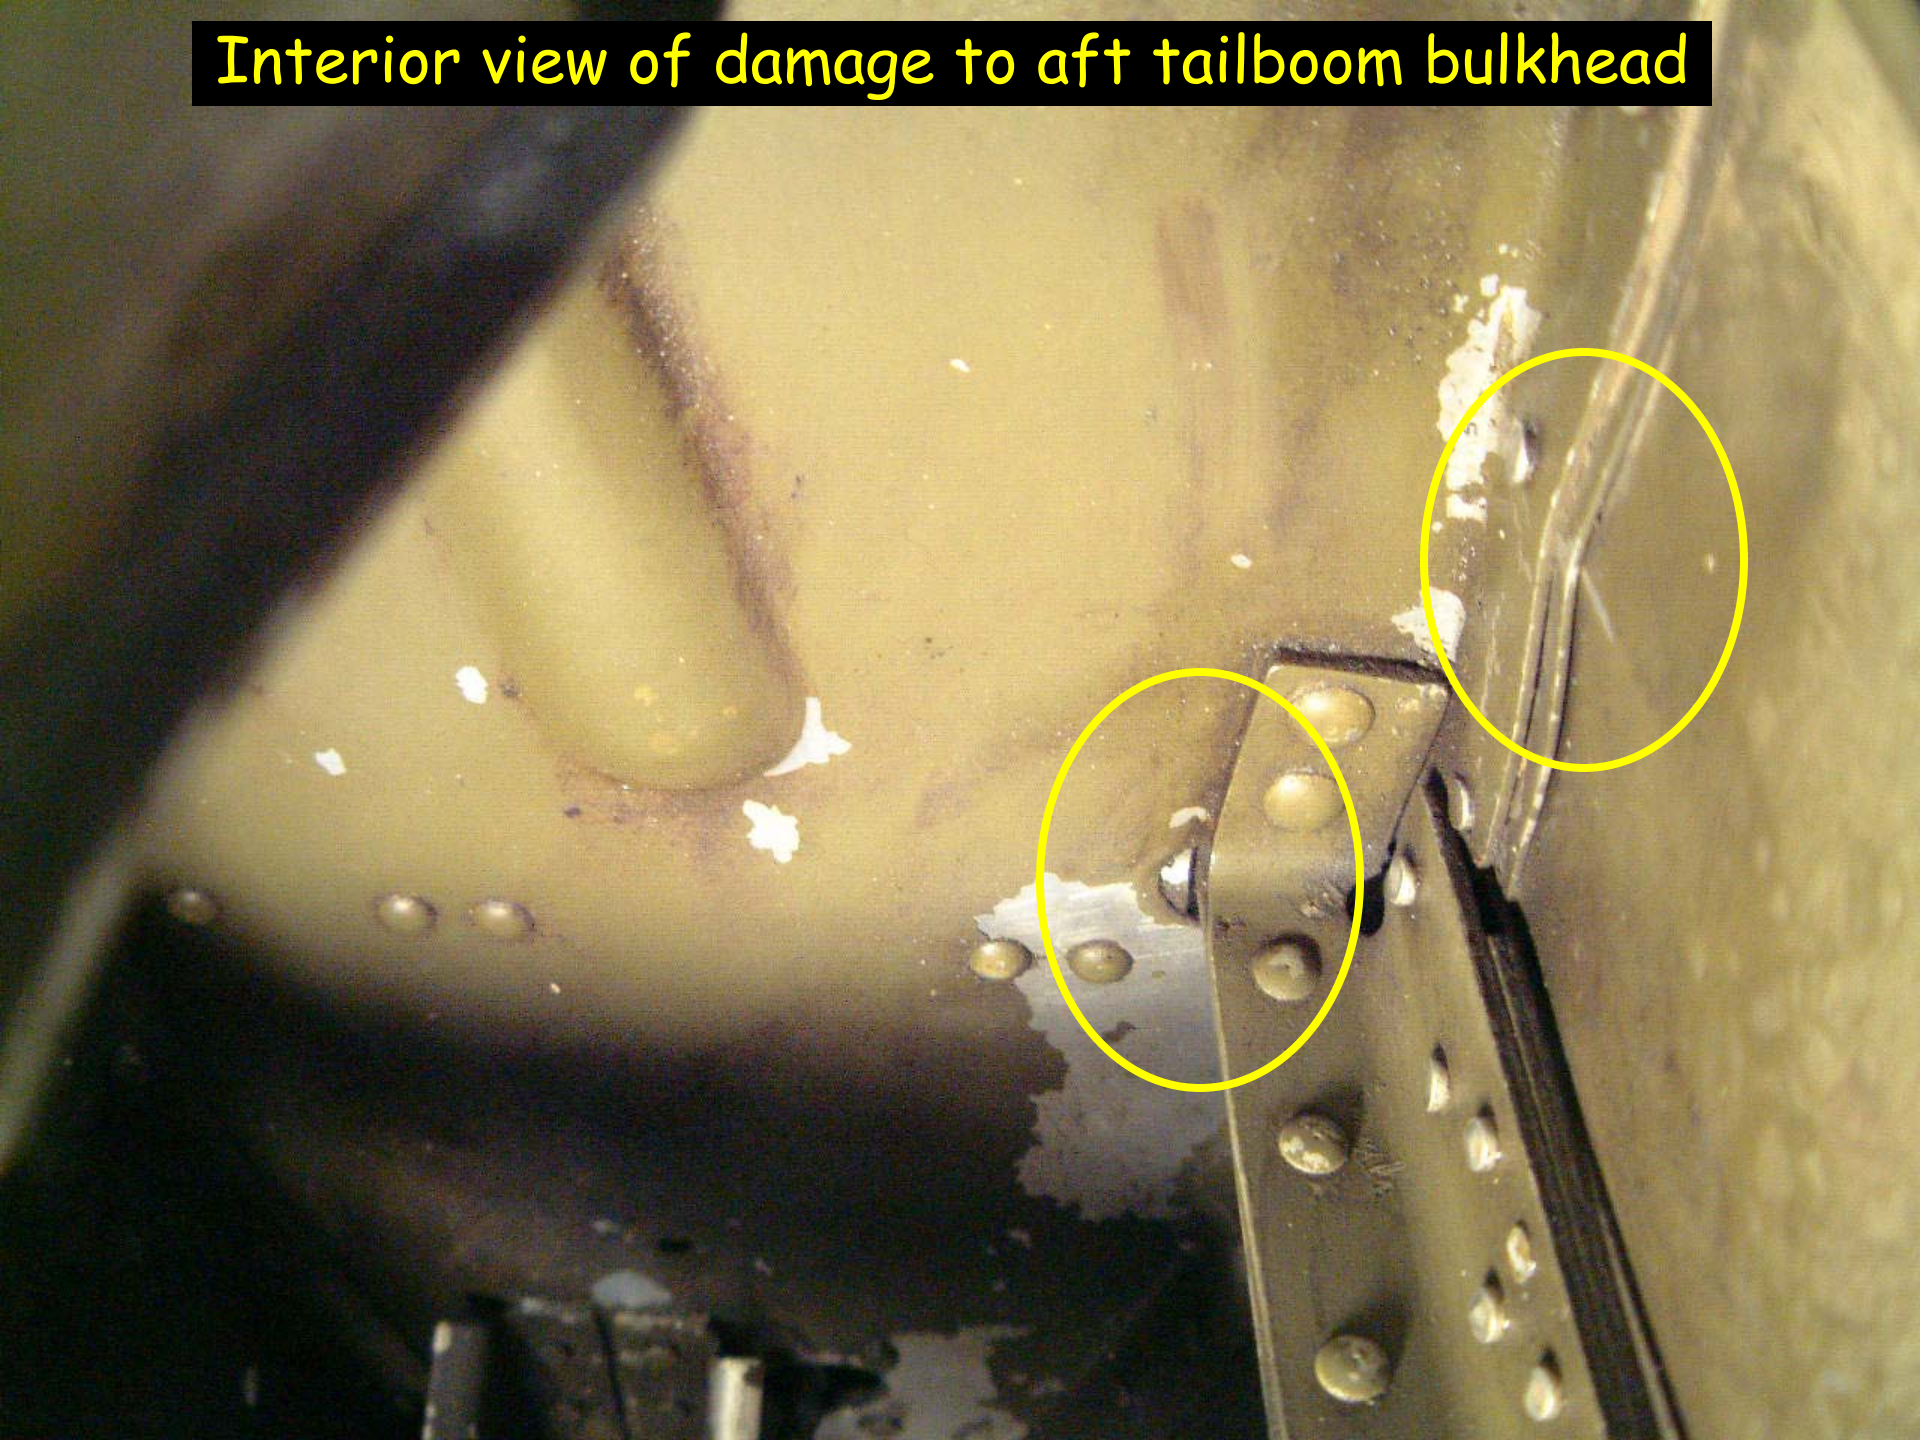
Interior view of damage to aft tailboom bulkhead

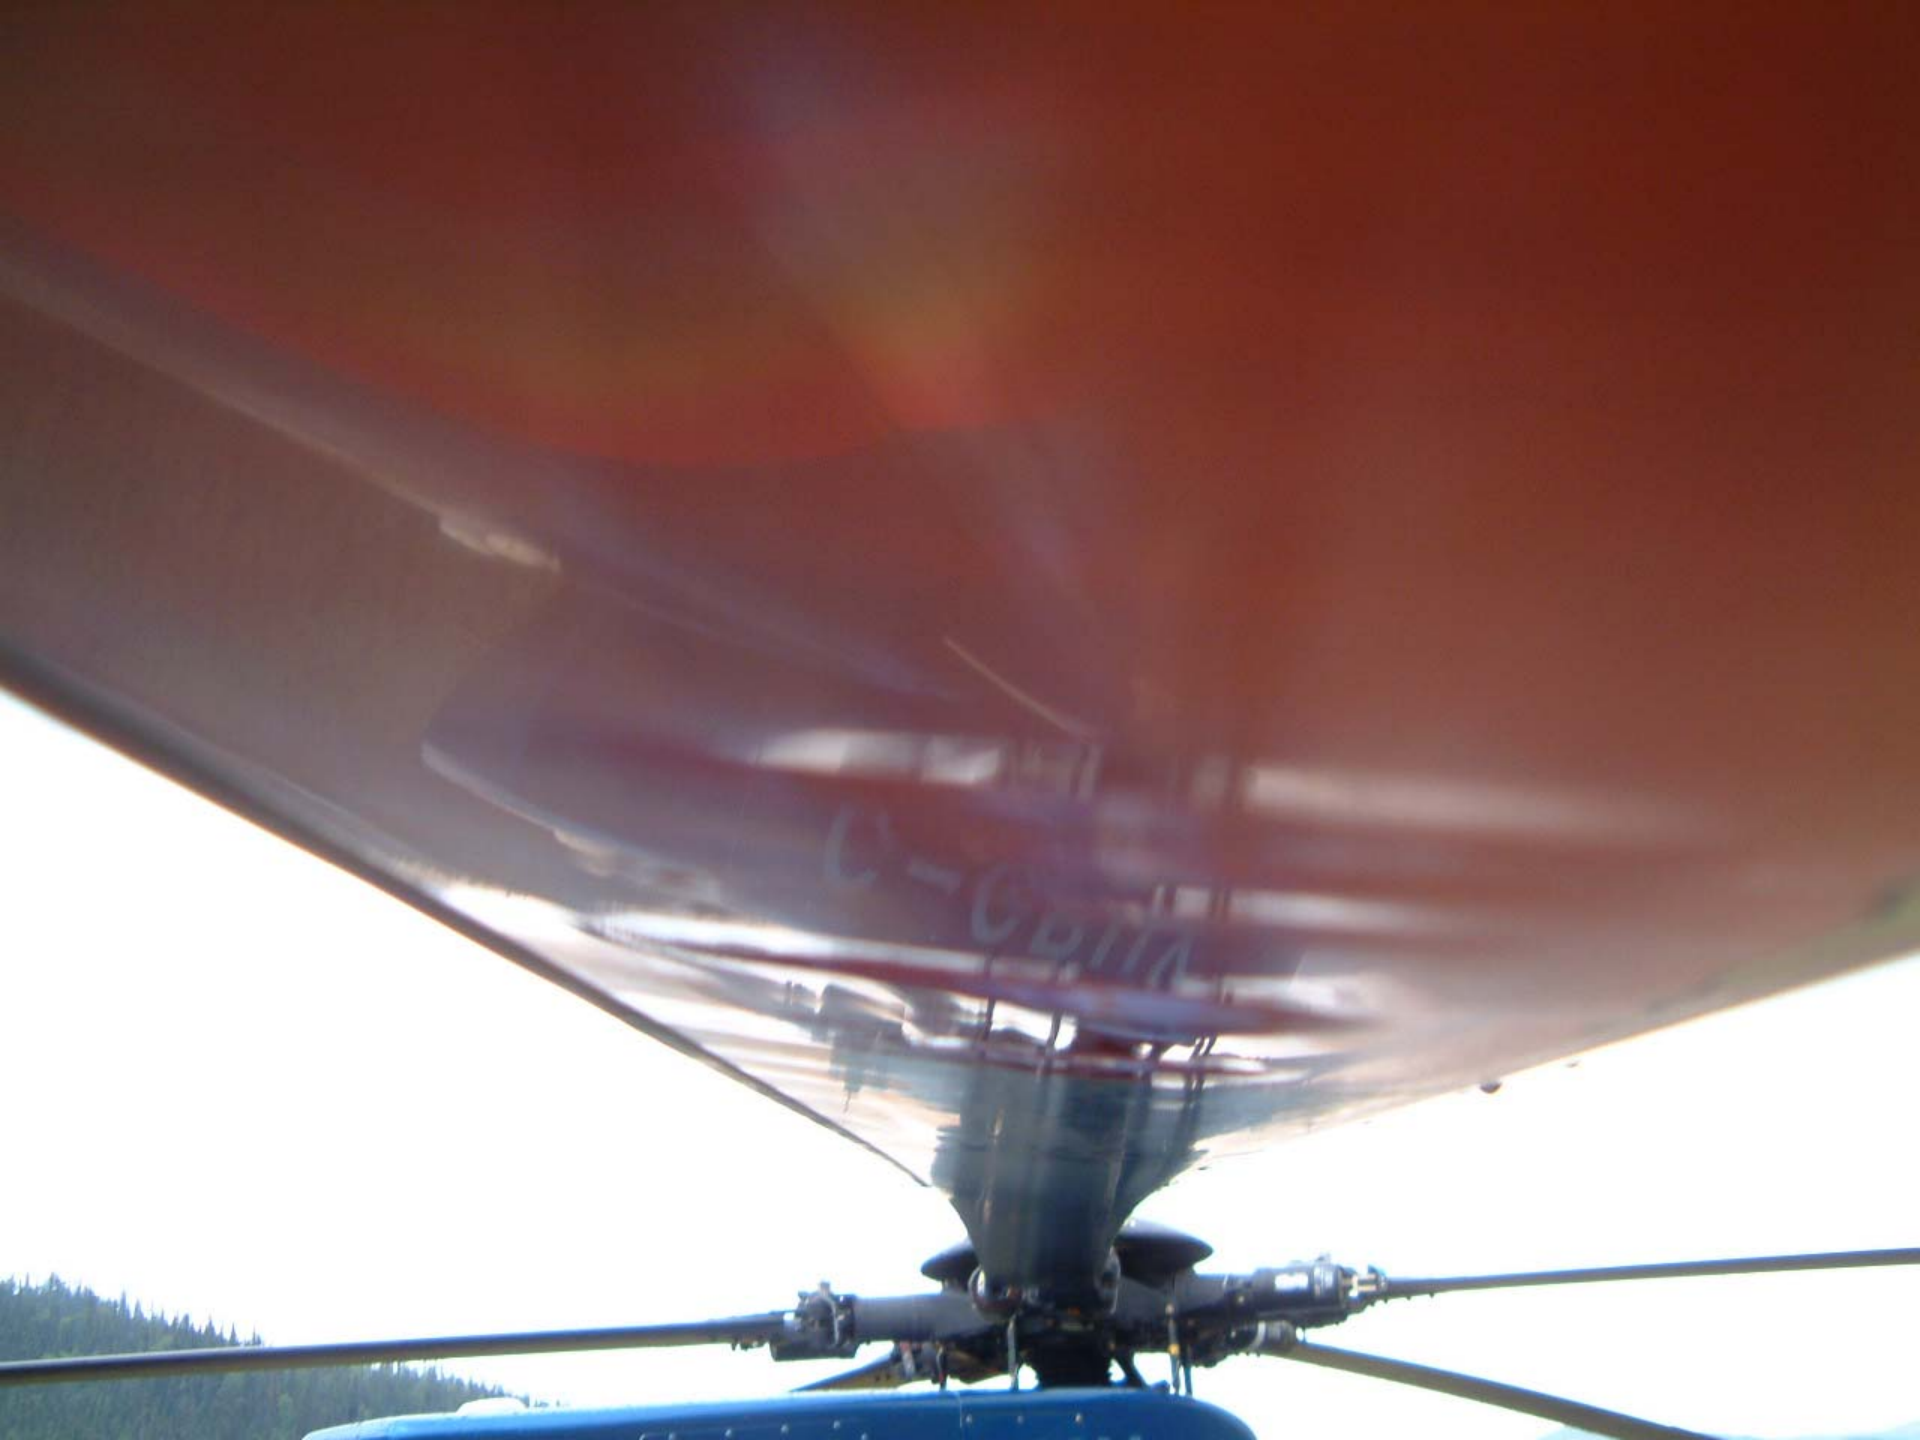
Tree Marks

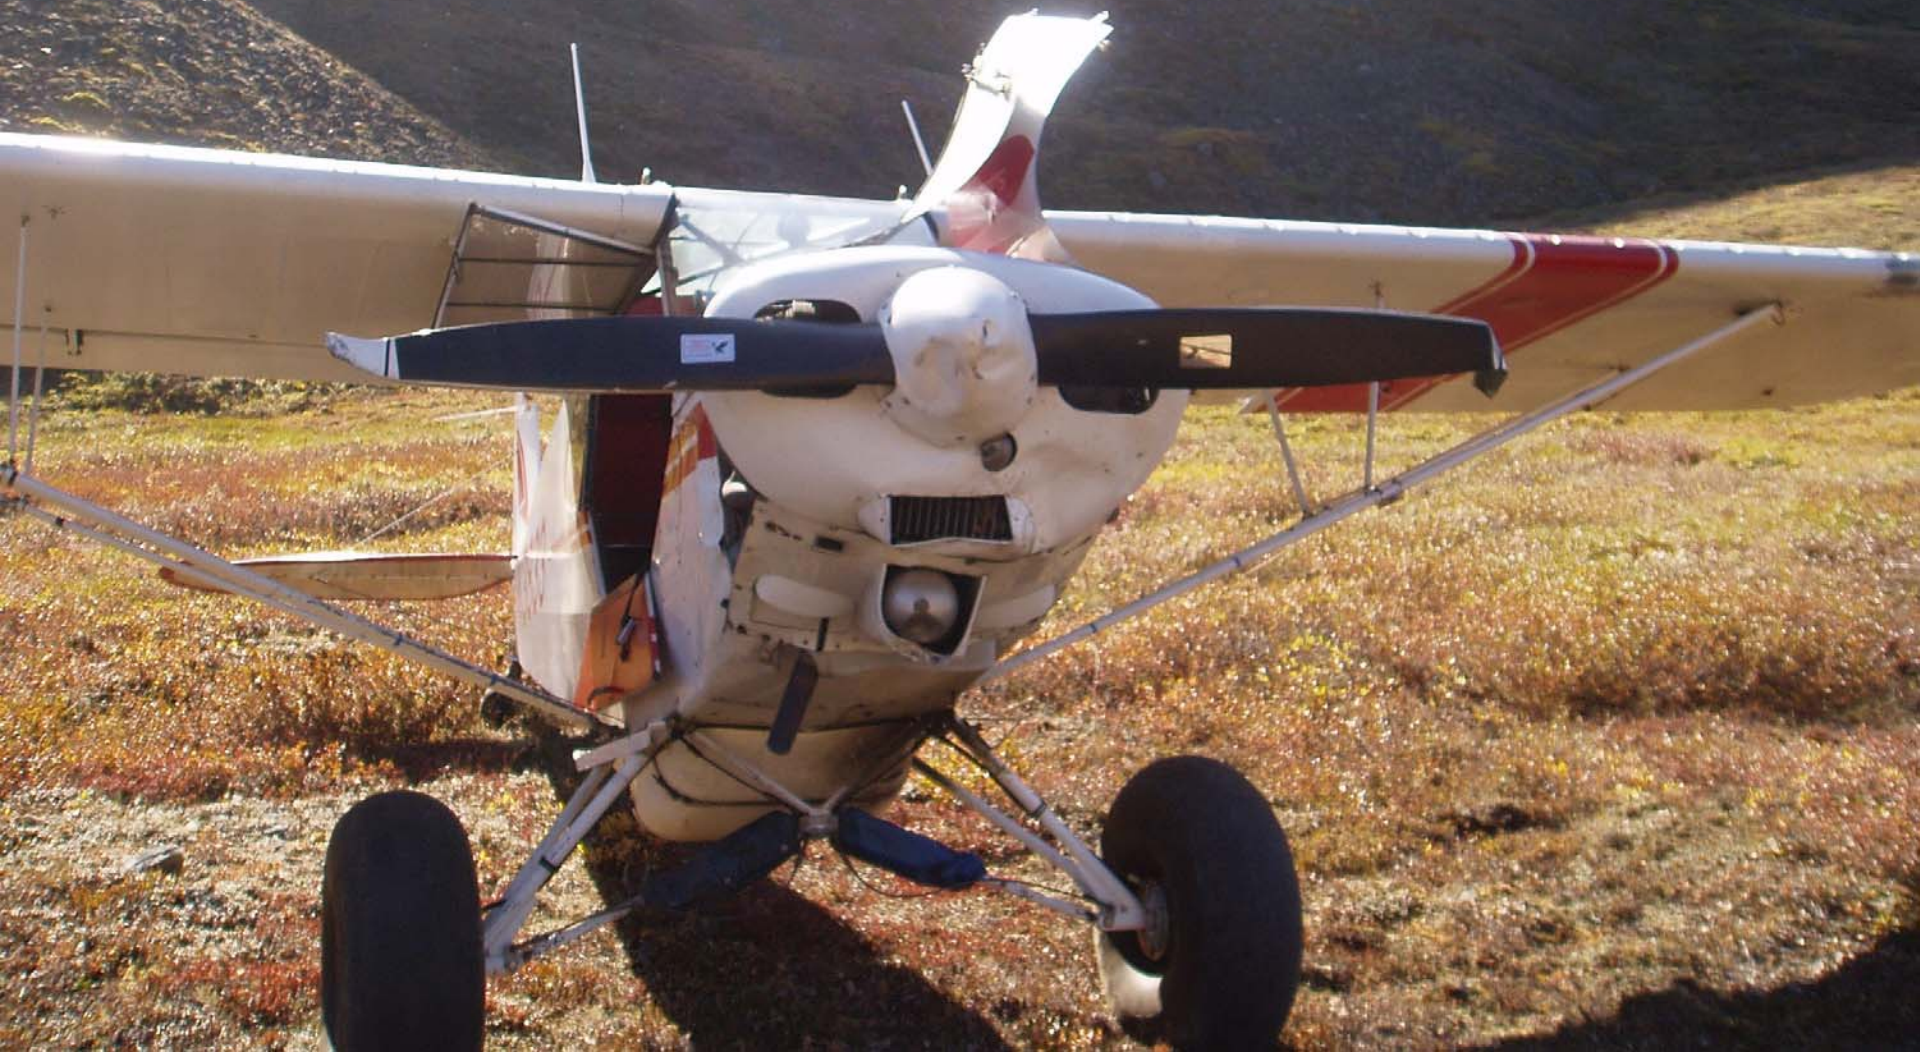
Engine deflected to the right
and damage to propeller blades

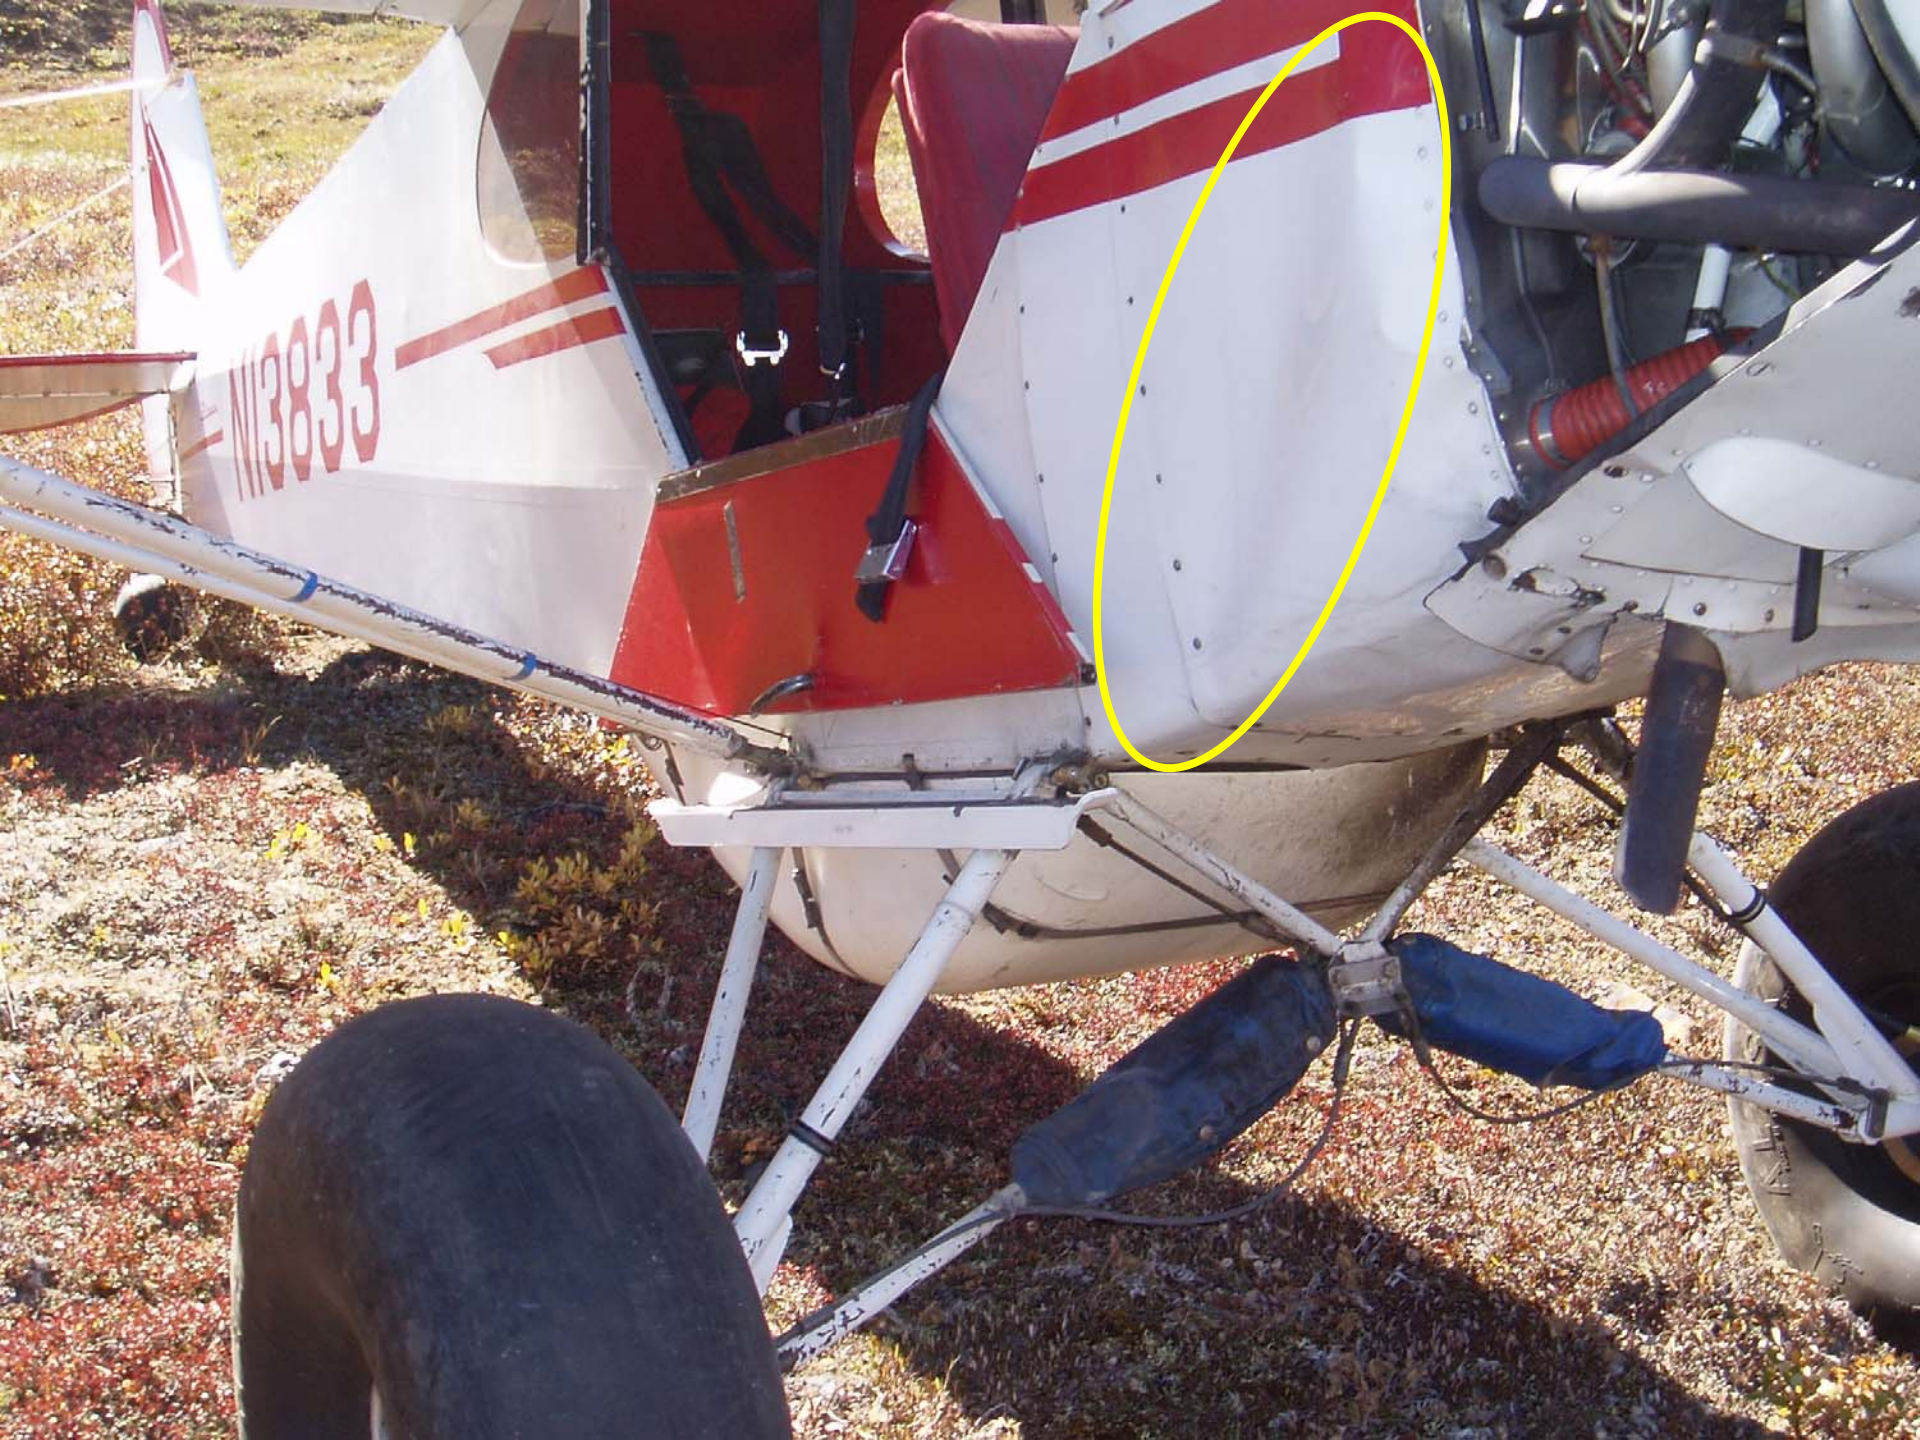
Damage to
firewall

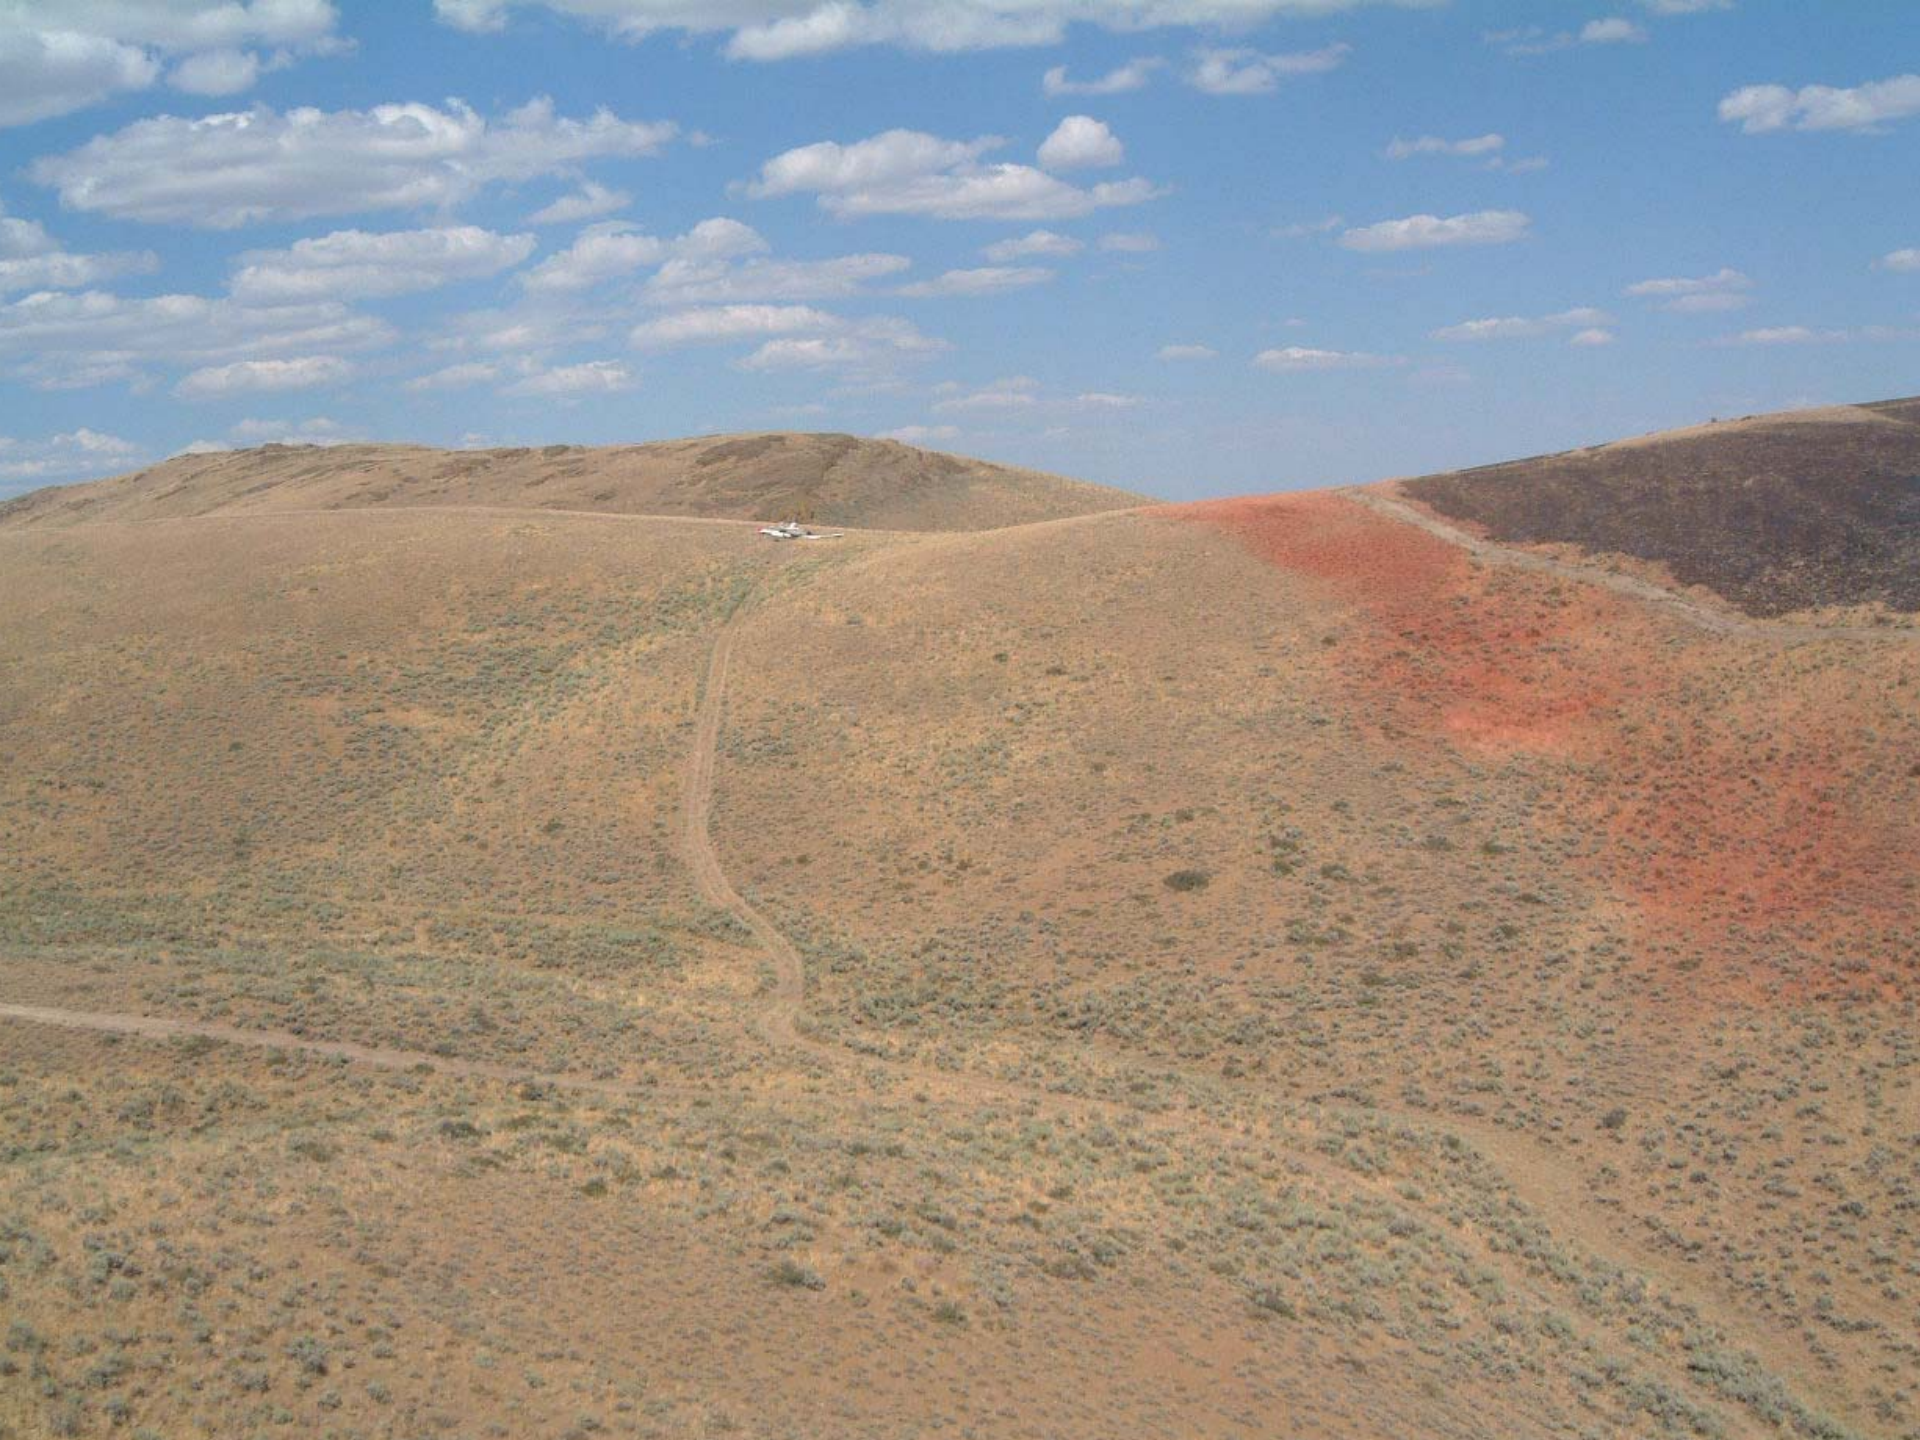
Point of initial impact

Heading 054°
